REPORT OF INVESTIGATION

Surface Nonmetal Mine
(Limestone)

Fatal Powered Haulage Accident
September 13, 2005

Newgate Development Corporation
West Pittsburg Quarry
West Pittsburg, Lawrence County, Pennsylvania
Mine I. D. No. 36-03441

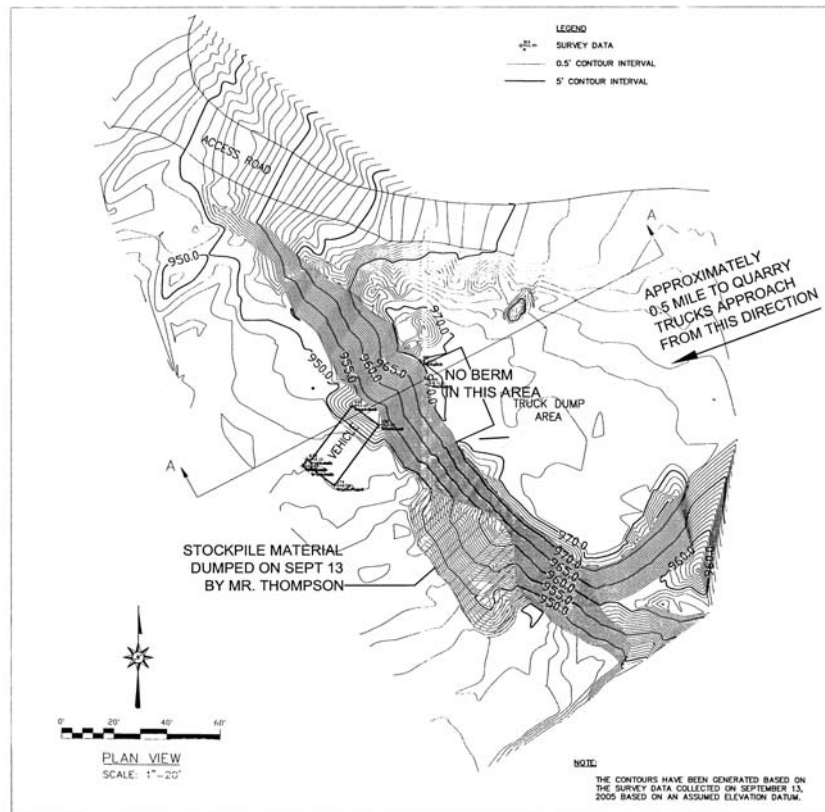
Figure 1 - Overview of Accident Scene

The accident occurred at the truck dump site located near the crushing and screening plant. Trucks dumped material from the edge of the permanent dump site to form a stockpile of raw material. The dump site had a gentle arc shape, with more pronounced curvature at the south end. At the location of the accident, the dump site was 21 feet high and 86 feet wide. The surface of the dump site sloped away from the edge at an average grade of 1.5 percent. However, at the accident location, the surface sloped away from the edge at 2.5 percent. A partial berm, between 30 and 32 inches high, existed along the edge of the dump site south of the accident location. However, there was no evidence that a berm existed at the location of the accident. For an overview of the accident scene, please refer to Figure 1.

The quarry was idle for nine days prior to the accident. During this time, the stockpiled material at the base of the dump site was depleted. Material comprising the dump site was also loaded out which resulted in oversteepening of the slope and the berm being removed in the area of the accident.

The oversteepened ledge of material appeared to have continued through the area where the accident occurred. This ledge of material was relatively weak and it failed when the rear tires of the truck backed to this area.

Tension cracks parallel to the crest were observed in the remaining ledge just south of the failure at a distance 2.5 feet back from the edge. The scarp remaining following the failure of the material in the accident area was nearly vertical. A sharp edge existed at the intersection of the scarp and the crown, indicating the failure of the ledge. As the rear of the truck dropped, the downward and lateral momentum caused it to tip and flip over onto the cab. A crease in the slope material was observed where the tail of the bed impacted the slope of the dump.

Corrective Action: Procedures should be established that require berms or similar impeding devices at the dump site to be maintained to prevent overtravel and to ensure that equipment is positioned at a safe distance from the edge of the slope.

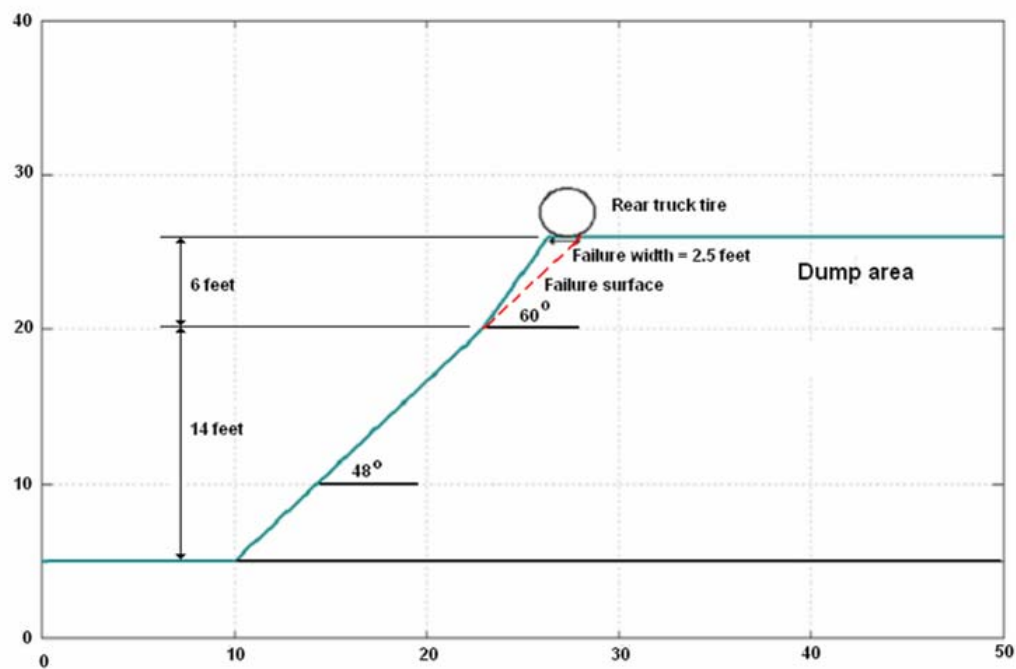
Figure 2 – Cross-section of Accident

Along the edge of the slope, immediately adjacent to where the accident occurred, a small ledge of material still existed. This material projected laterally approximately 2.5 feet out from the edge and had a height of about 6 feet. The slope of this material was oversteepened to about 60 degrees due to loadout operations at the toe of the dump area. Oversteepening of the slope resulted in a lowered resistance to failure (Figure 2).

Various cross sections measured at the dump site had overall slope angles ranging from 36 to 48 degrees with the upper portions of the slope generally steeper. The upper portion of the slope above the material dumped by Thompson showed a slope of

60 degrees. The material comprising the dump site had been compacted over time due to truck traffic and contained a significant portion of gravel and sand. The fine fraction of the material appeared to be non-plastic; therefore, the material was classified as cohesionless, meaning that the internal strength of the material was mainly attributed to confinement and friction. However, negative pore water pressures within the fine fraction of the soil created matrix suction forces that gave the soil an apparent cohesive strength. The inclusion of this cohesive strength and confinement from compaction permitted the slopes of the dump site to temporarily maintain an angle greater than the angle of repose.

Slope stability analyses were performed to verify the failure scenario. A frictional strength of 32 degrees was selected based on the gradation of the material comprising the ledge and the compaction history. This scenario showed that an apparent cohesive strength of approximately 300 pounds per square foot (psf) was required to maintain slope stability with a rear wheel loading of 123,280 pounds applied at the crest. This rear wheel loading occurred at the maximum gross vehicle weight of 184,000 pounds. It is unlikely that the material in the ledge possessed the 300 psf of apparent cohesive strength required to maintain stability.

Corrective Action: Procedures should be established to ensure that dumping locations are visually inspected prior to dumping the first load on every shift. Frequent inspections during the work shift should be performed for signs of slope instability. The top of the dump area should be examined for cracks, unstable ground, and sunken or soft areas. The load out area should be examined for signs of undercutting and oversteepening of the slope. Employees should be trained to Stop, Look, Analyze, and Manage (SLAM) each task to evaluate hazards and ensure steps are taken to safely perform tasks.
